Transport Accident  
Investigation  
Commission

## **Final report**

***Aviation inquiry AO-2019-001  
Airbus Helicopters AS350, ZK-HEX  
Forced landing  
Wakefield, Nelson  
17 February 2019***

**September 2020**

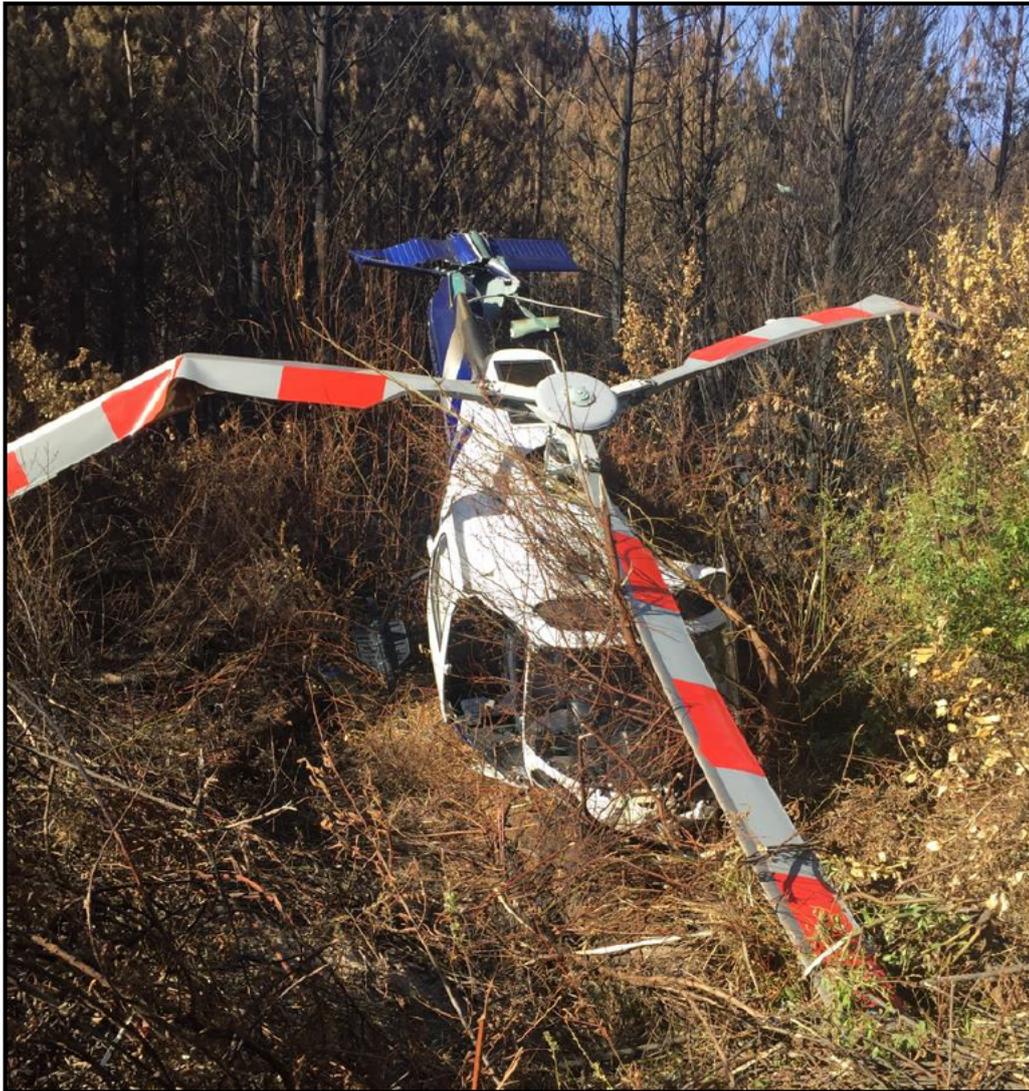
**Figure 3: Main wreckage at the accident site**

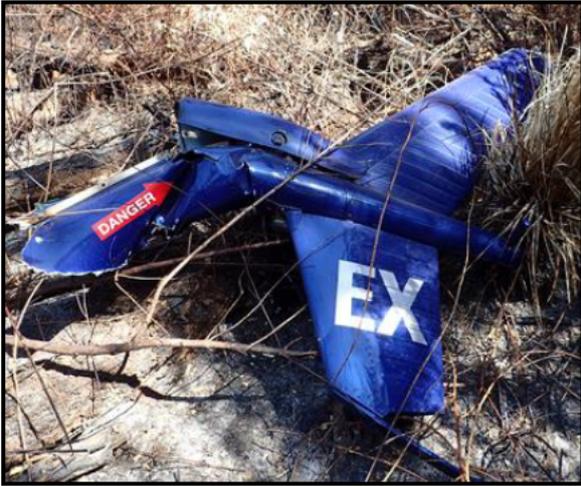
- 2.8. The main rotor blades were substantially damaged and appeared to have struck the tail boom and surrounding foliage. The rear section of the tail boom and the tail rotor assembly had separated from the main airframe (Figure 4) and landed a few metres to the right of the fuselage.

**Figure 4: Tail cone and tail rotor assembly at the accident site**

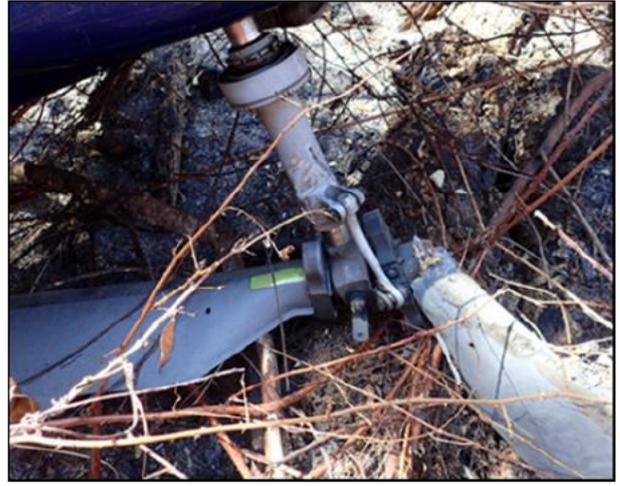
- 2.9. One tail rotor blade was broken at its root end but remained attached by its internal structure. The opposing tail rotor blade exhibited no external damage (see Figure 5).

**Figure 5: Broken tail rotor blade**

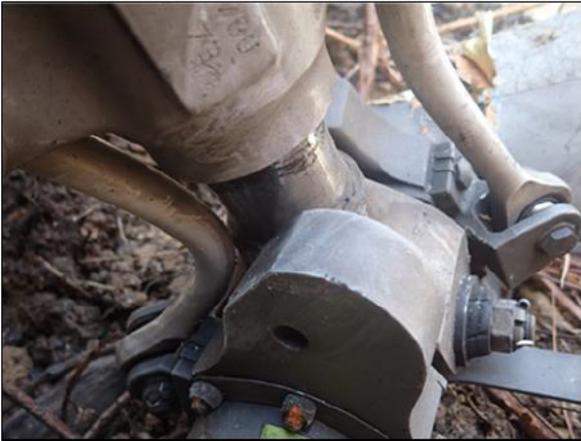
- 2.10. The two pitch control links<sup>6</sup> on the tail rotor assembly were found deformed (Figure 6) and the tail rotor pitch-control slider had numerous indentations (Figure 7).

**Figure 6: Pitch control links bent inward**

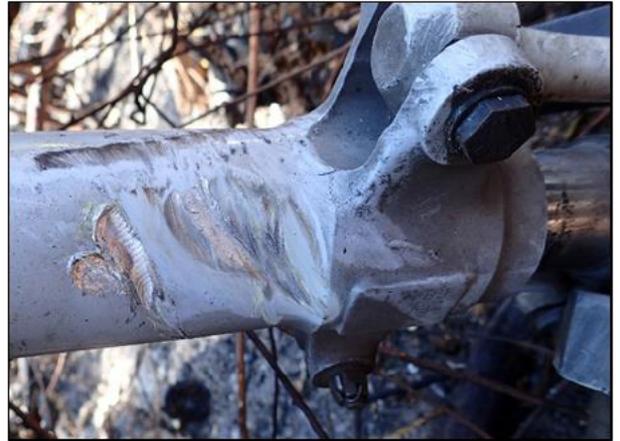
**Figure 7: Impact damage to the pitch control mechanism**

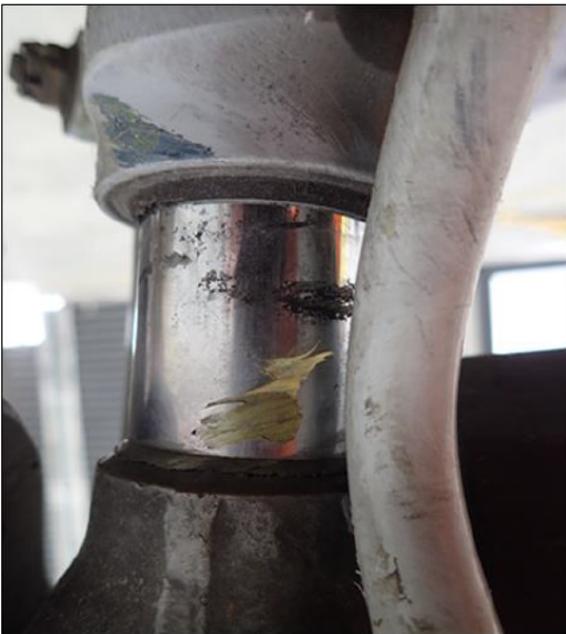
- 2.11. Yellow synthetic material was found on the tail rotor assembly at various locations (Figure 8). The same yellow material was also found on the leading edge of the broken tail rotor blade (Figure 9).

**Figure 8: Yellow material transfer on to tail rotor assembly**

The samples of the yellow deposit taken from the leading edge of the fractured blade and the yellow sleeve were analysed using Fourier transform infrared (FTIR) spectroscopy. This analysis showed that the FTIR spectra of both samples was very similar, indicating that both samples were the same polyvinyl chloride (PVC) type material.

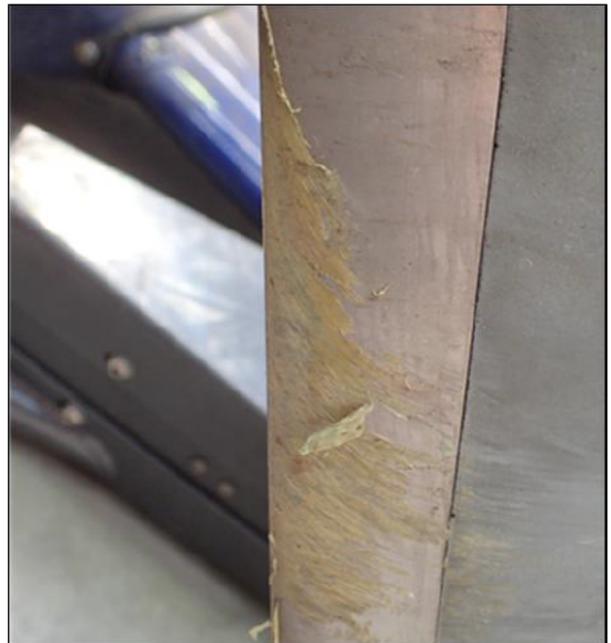
**Figure 9: Yellow material transfer on to tail rotor blade**

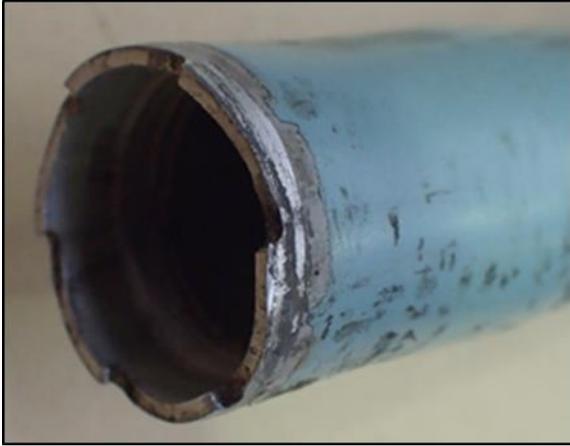
- 2.12. The tail rotor drive shaft had failed at its forward coupling (Figures 10 and 11).
- 2.13. The jettisoned bucket was found in a collapsed state in a forested area approximately 100 metres (m) to the south of the helicopter wreckage (Figure 12). A yellow synthetic sheathing was used to enclose the synthetic lifting line, electrical cable and pneumatic line (2.24); all of these exhibited damage at about the same point along the length of line (Figure 13).

**Figure 10: Forward end of the tail rotor drive shaft**

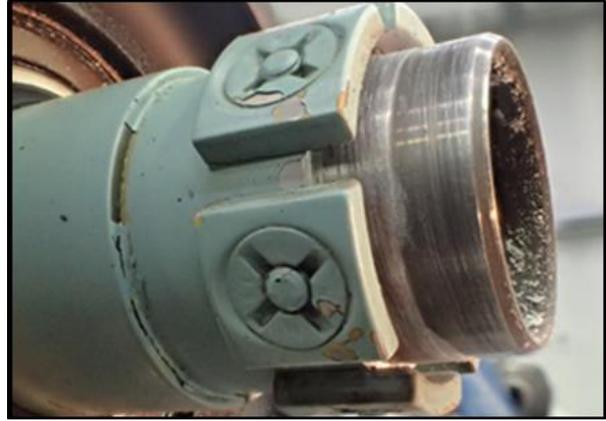
**Figure 11: Forward coupling of the tail rotor drive shaft**

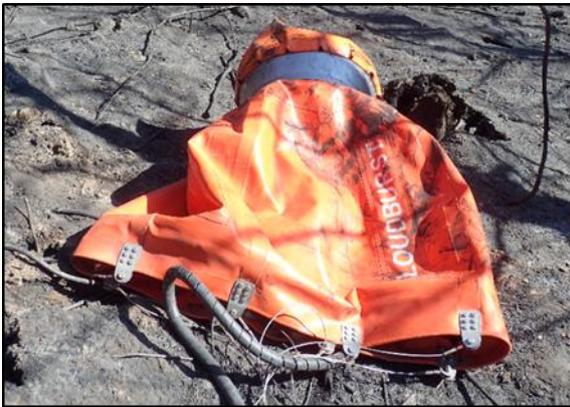
**Figure 12: Bucket in collapsed state in situ at the accident site**

- 3.18. The jettisoned bucket was recovered from a forested area at a location approximately 100 m from where the helicopter came to rest. The initial examination of the bucket found that a number of the hook-and-loop fastener tabs had been displaced, the tubular, segmented, stainless-steel ring was no longer in place, and the top of the bucket had collapsed (Figure 12).

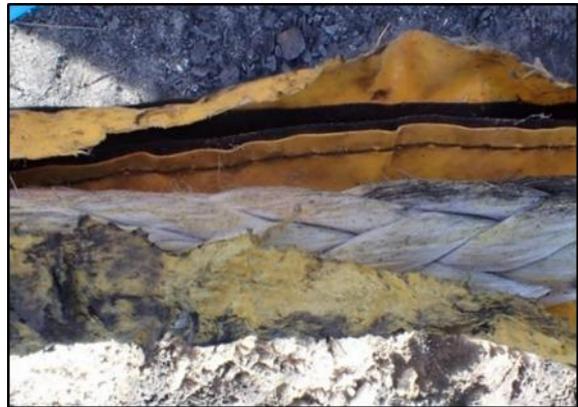
**Figure 13: Damage to the lifting line sheathing material**

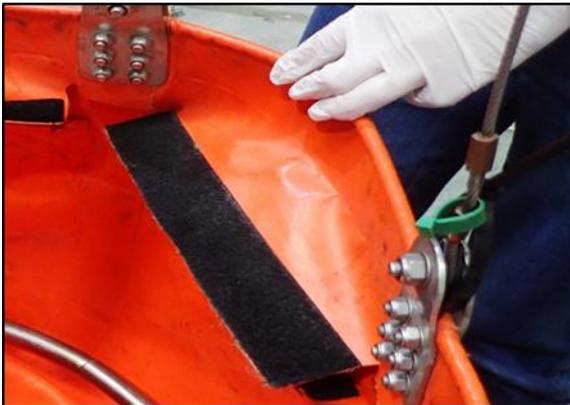
- 2.14. The bucket was inspected in situ. A tubular, segmented, stainless-steel ring normally held in place by hook-and-loop fastener tabs<sup>7</sup> at the top of the bucket (Figure 14) had come apart and was displaced.

**Figure 14: Hook-and-loop fastener tab**

- 3.19. The top section of the lifting line was suspended in a tree and it appeared to have struck tree branches as it fell. One of the hook-and-loop fastener tabs appeared worn when compared to the other tabs. This particular tab was located below the weighted edge, which was at the front of the bucket in normal flight.

- 3.20. A post-accident examination conducted by the Commission with the assistance of the manufacturer determined that while one of the hook-and-loop fasteners appeared worn, it was capable of supporting the forces expected when filled with water. However, this did not consider the additional aerodynamic loads experienced by the bucket in flight.

- 3.27. Monsoon buckets used for firefighting operations are inherently exposed to harsh operating conditions, where submerged objects or waves may impart forces on the hook-and-loop fasteners. This creates the potential for hook-and-loop fasteners to come undone during operations, as evidenced by the previous occurrences and this accident. Therefore, the Commission has made a recommendation to the manufacturer that all Cloudburst monsoon buckets be fitted with the new design.

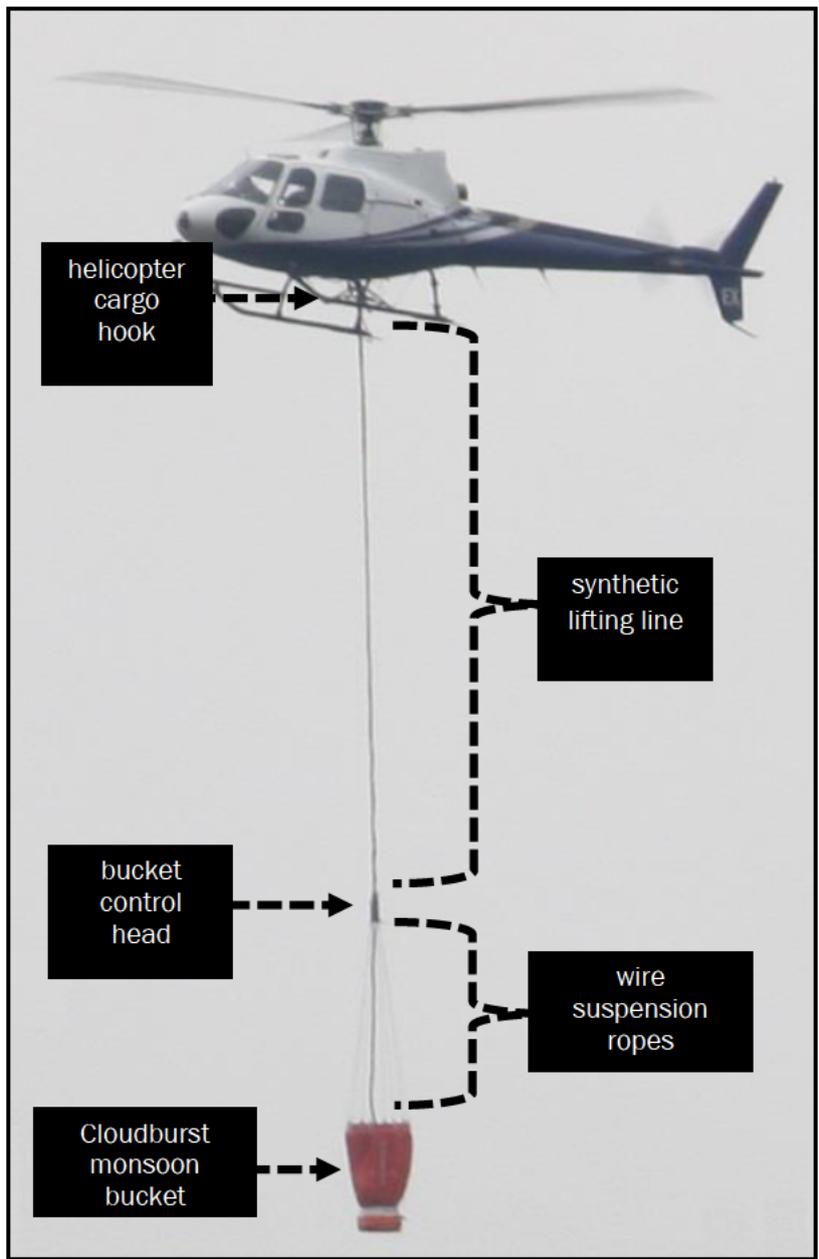
- 2.25. The bucket was suspended below the bucket control head by eight, 3 m-long steel cables (Figure 15). The symmetrical profile of the bucket was maintained by the pressure of the water acting on the inside surface of the bucket (Figure 16) when carrying water and by the tubular, segmented, stainless-steel ring in the upper section of the bucket when empty.

**Figure 15: Bucket rigging configuration  
(credit: Andy Heap)**

- 3.39. The lifting line used on the accident flight was 8.5 m in length. The Commission identified that three additional accidents had occurred, in New Zealand, Italy and France respectively, involving fire buckets contacting the tail rotors of AS350 helicopters<sup>22</sup>. All four of these helicopters were configured with lifting line lengths placing the buckets within the recommended 'no-go' zone as defined by the Bambi Bucket Operations Manual and the Airbus Safety Information Notice.

- 3.41. The Commission is therefore of the opinion that the recommended limitations for tail rotor clearance, such as described in the Bambi Bucket Operations Manual and the Airbus Safety Information Notice, should be applied to all monsoon buckets.
