Transport Accident  
Investigation  
Commission

## **Final report**

***Aviation inquiry AO-2019-001  
Airbus Helicopters AS350, ZK-HEX  
Forced landing  
Wakefield, Nelson  
17 February 2019***

**September 2020**

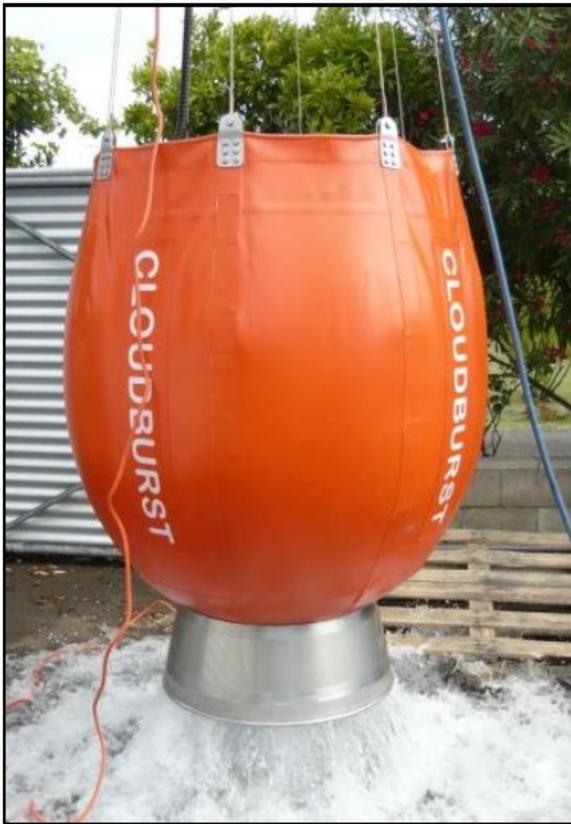
- 2.25. The bucket was suspended below the bucket control head by eight, 3 m-long steel cables (Figure 15). The symmetrical profile of the bucket was maintained by the pressure of the water acting on the inside surface of the bucket (Figure 16) when carrying water and by the tubular, segmented, stainless-steel ring in the upper section of the bucket when empty.

**Figure 16: Cloudburst 1000 bucket filled during testing (credit: IMS New Zealand)**

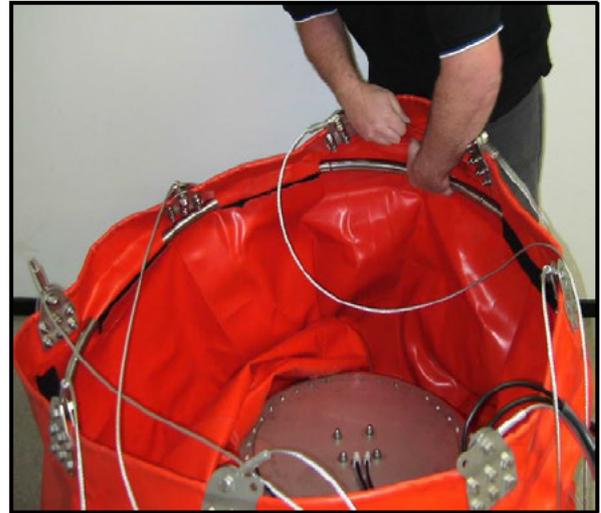
- 1.3. A tubular, segmented, stainless-steel ring was held in place at the top of the bucket with hook-and-loop fastener tabs. This ring was intended to maintain the circular shape of the top section of the bucket when it was being filled.

**Figure 17: Stainless-steel ring retained in bucket with hook-and-loop fastener (credit: Cloudburst Operation Manual)**

- 1.5. The bucket manufacturer had developed design improvements to reduce the likelihood of the hook-and-loop fastener tabs coming undone, but the modification was not mandatory. Therefore, the Transport Accident Investigation Commission (Commission) has made a **recommendation** that the Cloudburst monsoon bucket manufacturer ensure that all Cloudburst monsoon buckets with this hook-and-loop fastener system are modified with the design improvements.

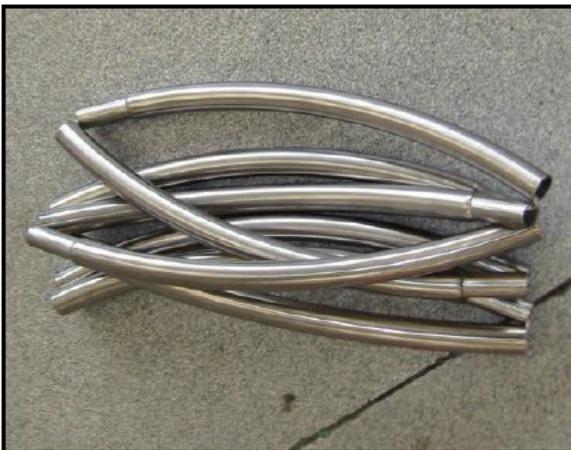
- 2.27. When assembling the bucket for deployment, the eight hook-and-loop fastener tabs (Figure 14) could be opened to accept the tubular, segmented, stainless-steel ring in the upper section of the bucket, then closed to secure it. This allowed disassembly for transport and storage (Figures 18 and 19). The ring had the effect of keeping the top section of the bucket rigid when empty. The operator had kept the bucket in a fully assembled state while in storage to enable rapid deployment.

**Figure 18: Segmented stainless-steel ring (credit: Cloudburst Operation Manual)**

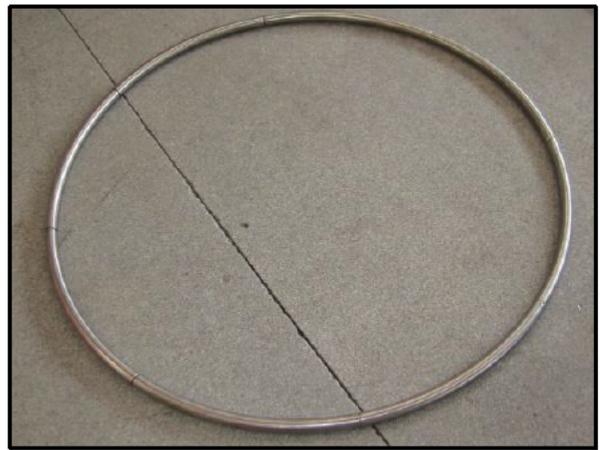
**Figure 19: Stainless-steel ring assembled (credit: Cloudburst Operation Manual)**

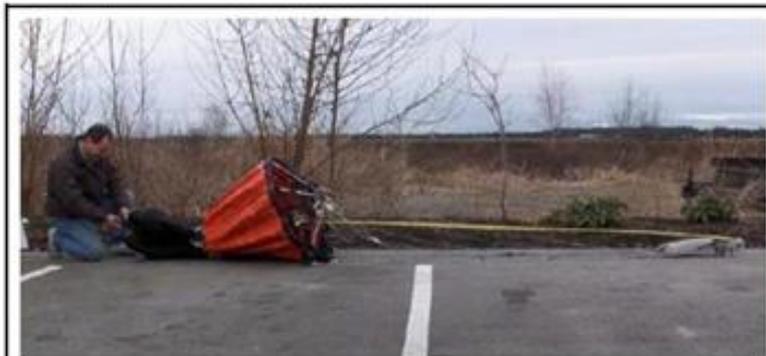
For Bambi Bucket-type water bombing systems, the manufacturer's Operations Manual recommends a maximum speed (VNE) of 80 knots for all operations. In the case of short line operations, the total length of the system (firesock deployed) must be less than the length from the cargo sling/swing hook to the tail rotor disc decreased by at least 6 inches (=150 mm).

*Measuring the bucket. If a Firesock is to be used, attach first and then measure to the bottom of the sock. See Section 4: Flight Operations for information on how to use the Firesock.*
